**Somalia Food Systems  
Resilience Project “P177816**

## **ENVIRONMENTAL AND SOCIAL MANAGEMENT PLAN (ESMP)**

Rangeland Rehabilitation Rako District, Puntland

Food Systems Resilience Project (FSRP) – Puntland Component

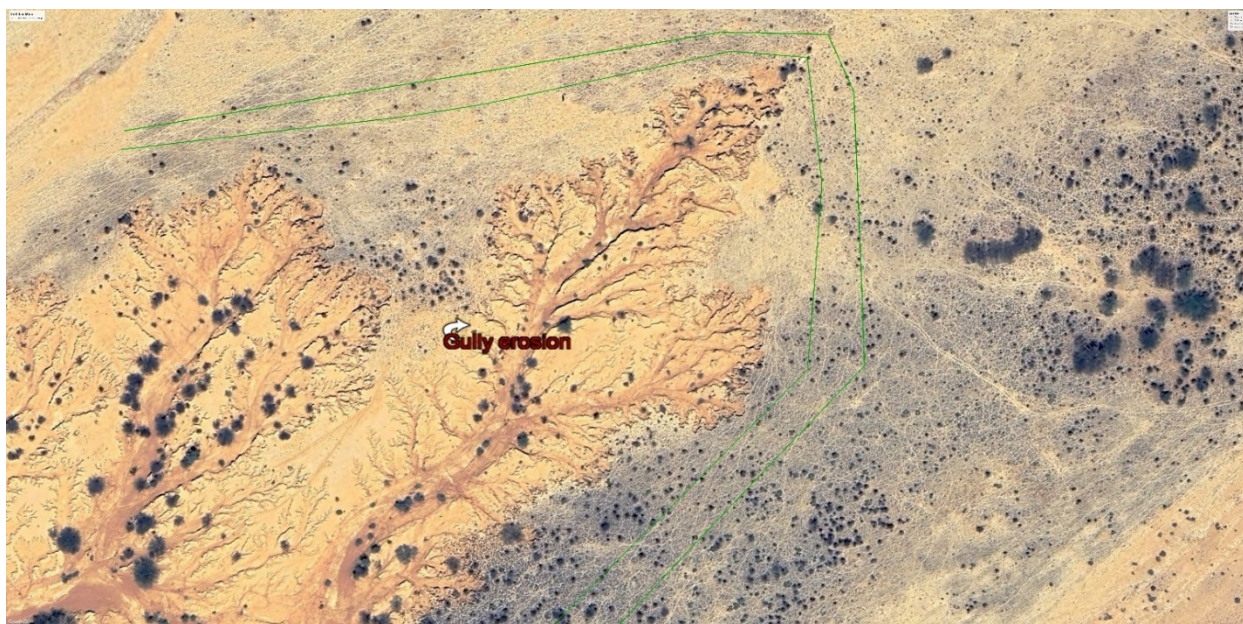
Figure 1: Rako site map

GPS coordinates recorded during the field assessment are: **9°45'03.9"N 49°43'17.5"E**.

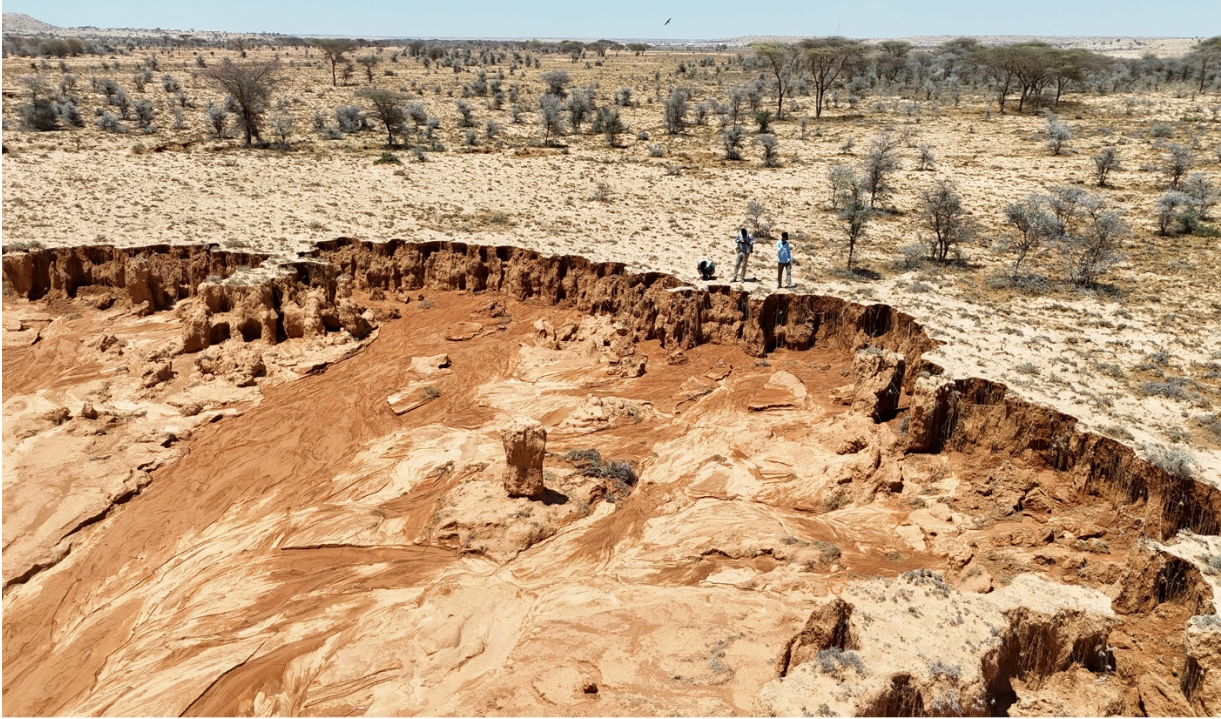
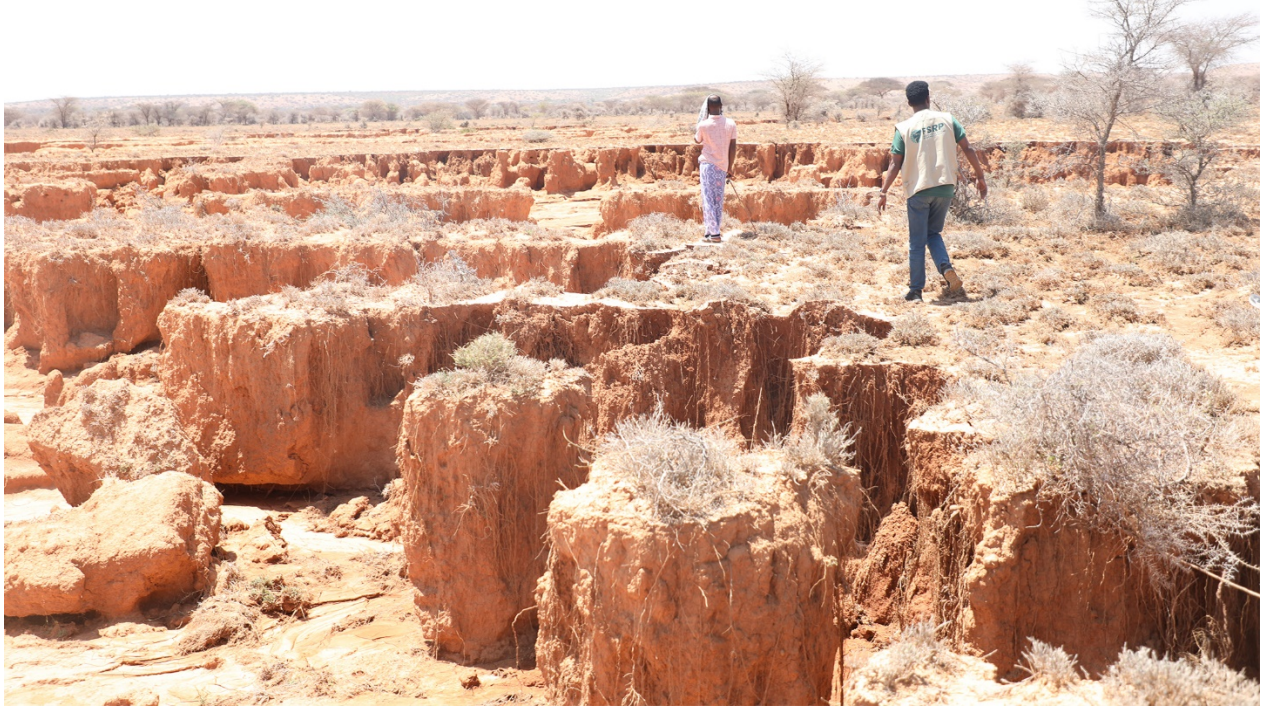
## 10.4. Photos for Site Observation

The terrain is gently sloping within a medium-sized watershed system (189 km<sup>2</sup>) in Rako, with soils that are weakly structured, erosion-prone, and susceptible to gully formation. Active gully erosion is observed at the Kodmo site, with deep incision, head-cut advancement, and widening channels driven by concentrated runoff during rainfall events.
