Environmental and Social Management Plan (ESMP)

Nuux Primary Canal Rehabilitation (in Mareerey Village, Afgoye District, Southwest State)

FOOD and AGRICULTURE ORGANIZATION(FAO)

Somalia Food System Resilience Program (S-FSRP)
Technical Assistance
Component 5: Contingency Emergency Response Component
UTF/SOM/088/SOM

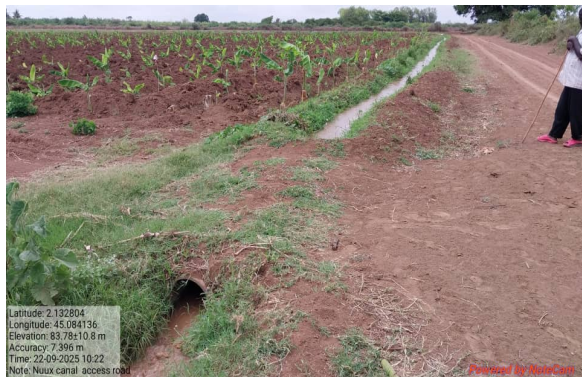
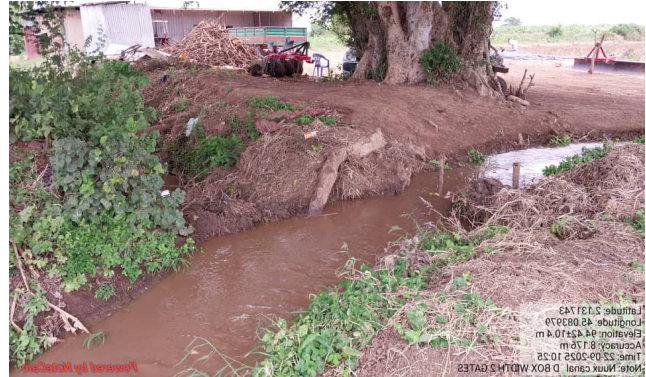
Figure 2-Canal current situation

Field assessments were conducted jointly by the FAO safeguards team, the Federal Ministry of Agriculture and Irrigation (MoAI), the Southwest State Ministry of Agriculture and Irrigation, and the local canal committee. The joint mission inspected the full Nuux Primary Canal corridor and documented the following conditions:

The intake structure requires desilting and structural stabilization to restore full flow diversion capacity. Most division boxes exhibit concrete deterioration, sediment accumulation, or partial blockage that restricts water distribution. The culverts require excavation, clearance, and channel alignment to allow unobstructed passage and prevent localized flooding during high flow conditions.

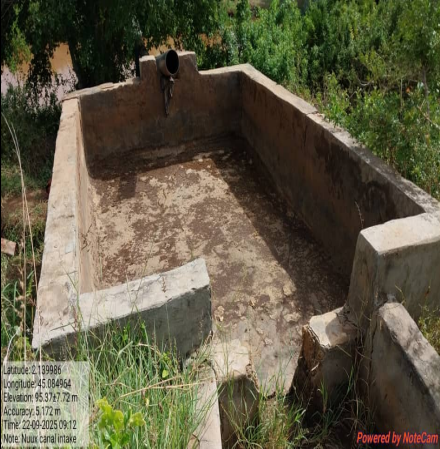
<p>Latitude: 2.139986 Longitude: 45.084564 Elevation: 95.314772 m Accuracy: 5.172 m Time: 22-09-2025 09:12 Note: Naik canal intake Powered by NoteCam</p> <p>Figure 3-Canal condition</p>	2.139986, 45.084564	It is recommended that the existing brick intake tank be rehabilitated and upgraded to a reinforced concrete structure to ensure long-term durability, improved hydraulic performance, and reduced maintenance requirements. The reconstruction should include the installation of concrete walls and a properly sealed base to minimize leakage and enhance structural stability. Additionally, the inlet and outlet channels should be reshaped and aligned to optimize water flow and maximize intake efficiency.

Stations	Structure Type	Condition Description	Photo Ref. #	GPS	Recommended Action
0+020	Intake Tank	The intake tank is currently made of bricks and requires reconstruction with concrete walls to enhance its functionality and maximize water intake.

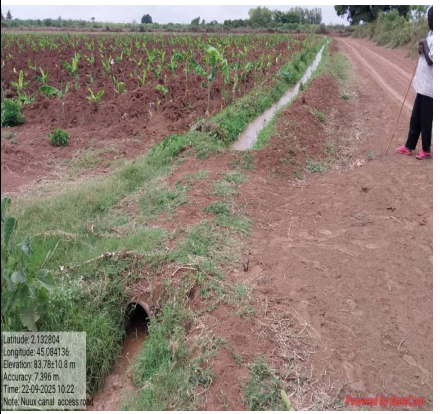
<p>Latitude: 2.132804 Longitude: 45.084136 Elevation: 83.781108 m Accuracy: 7.396 m Time: 22-09-2025 10:22 Note: Naik canal access Powered by NoteCam</p> <p>Figure 4-Canal condition</p>	2.132804, 45.084136	It is recommended to construct a new reinforced concrete culvert (4.9 m wide) to facilitate smooth canal water flow beneath the access road. The structure should include properly compacted approaches, headwalls, and wing walls to prevent erosion and ensure long-term durability.

0+850	Proposed Crossing Culvert	Currently, there is no existing culvert structure. Water passes beneath the road through a temporary buried pipe, which is inadequate for proper discharge and often causes blockage during heavy flow.
