## **Environmental and Social Management Plan (ESMP)**

### **Abshir Primary Canal Rehabilitation (in Mareerey Village, Afgoye District, Southwest State)**

**FOOD and AGRICULTURE ORGANIZATION (FAO)**

Date: February 2026

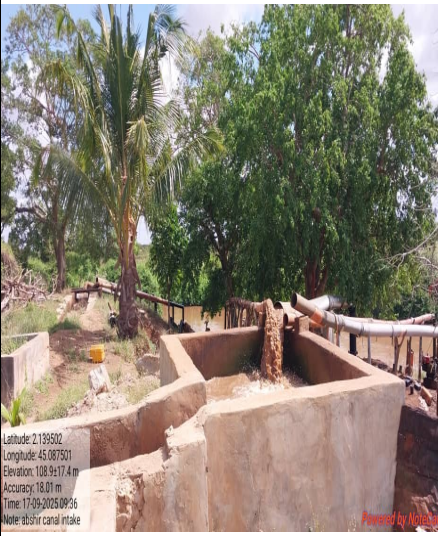
<p><b>0+020</b></p>	<p><b>Intake Tank</b></p>	<p>The intake tank is currently made of bricks and requires reconstruction with concrete walls to enhance its functionality and maximize water intake.</p>

<p><i>Figure 3-Canal condition</i></p> <p><i>Figure 4-Canal condition</i></p>	<p><b>2.139502, 45.087501</b></p>	<p>It is recommended that the existing brick intake tank be rehabilitated and upgraded to a reinforced concrete structure to ensure long-term durability, improved hydraulic performance, and reduced maintenance requirements. The reconstruction should include the installation of concrete walls and a properly sealed base to minimize leakage and enhance structural stability. Additionally, the inlet and outlet channels should be reshaped and aligned to optimize water flow and maximize intake efficiency.</p>
<p><b>0+012</b></p>	<p><b>Generator</b></p>	<p>The Generators are currently operational; however, farmers report that it consumes a significant amount of fuel, making its operation costly. During flooding events, the pump system becomes vulnerable and often experiences operational disruptions.</p>

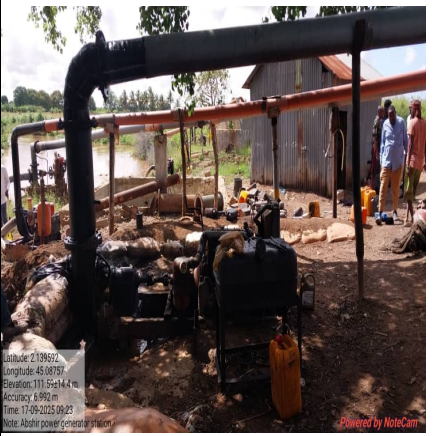
<p><i>Figure 5-Canal condition</i></p> <p><i>Figure 6-Canal condition</i></p>	<p><b>2.139592, 45.08757</b></p>	<p>The existing diesel-powered pump system at Abshir station is functional but costly to operate due to high fuel consumption and frequent disruptions during floods. It is recommended to transition to a <b>solar-powered or hybrid solar-diesel pumping system</b> to reduce operational costs and improve reliability. Additionally, a <b>reinforced flood protection barrier</b> should be constructed around the pump area, and key equipment should be <b>elevated above flood level</b> to ensure uninterrupted operation during high-water events.</p>
