## **Environmental and Social Management Plan (ESMP)**

### **Mukhtar Primary Canal Rehabilitation (in Mareerey Village, Afgoye District, Southwest State)**

**FOOD and AGRICULTURE ORGANIZATION(FAO)**

Somalia Food System Resilience Program (S-FSRP)  
Technical Assistance  
Component 5: Contingency Emergency Response Component  
UTF/SOM/088/SOM

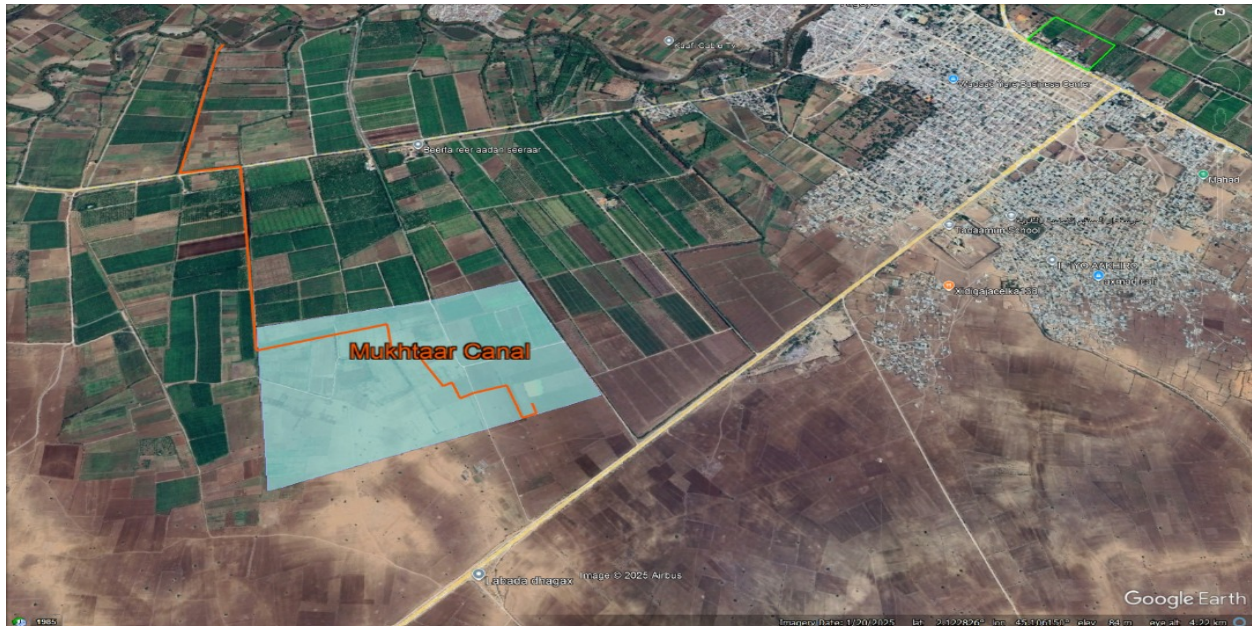
Figure 1: Geo-Map photo of the canal

The Mukhtar Primary Canal is a critical irrigation canal system located in Afgoye District, Lower Shabelle Region, within Southwest State of Somalia. The canal supports agricultural production across a historically productive command area that has experienced a significant reduction in irrigated hectares and reliability of water delivery due to progressive siltation, bank erosion, and deterioration of auxiliary hydraulic structures. Assessed under Subproject A of the Somalia Food Systems Resilience Program (S-FSRP), the canal was prioritized for rehabilitation based on stakeholder recommendations, availability of complete baseline data, and the severity of service disruption affecting local farmers.

The canal extends 5.55 kilometers (5,550 meters) and historically irrigated 120 hectares of farmland. Due to sediment accumulation, deterioration of hydraulic structures, and reduced flow conveyance efficiency, the current functional irrigated area has remained 107 hectares, representing a substantial reduction in productive land. The number of active beneficiary farmers has decreased from 70 historically to 35 currently, with 45 farming households relying on the canal system for irrigation and livelihood activities.

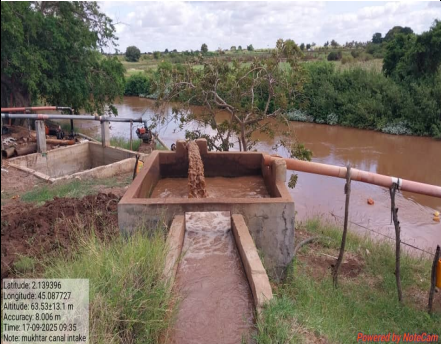
<p>Figure 3-Canal condition</p>	2.139396, 45.087727	It is recommended that the existing brick intake tank be rehabilitated and upgraded to a reinforced concrete structure to ensure long-term durability, improved hydraulic performance, and reduced maintenance requirements. The reconstruction should include the installation of concrete walls and a properly sealed base to minimize leakage and enhance structural stability. Additionally, the inlet and outlet channels should be reshaped and aligned to optimize water flow and maximize intake efficiency.

The intake structure requires desilting and structural stabilization to restore full flow diversion capacity. Most division boxes exhibit concrete deterioration, sediment accumulation, or partial blockage that restricts water distribution. The culverts require excavation, clearance, and channel alignment to allow unobstructed passage and prevent localized flooding during high-flow conditions.

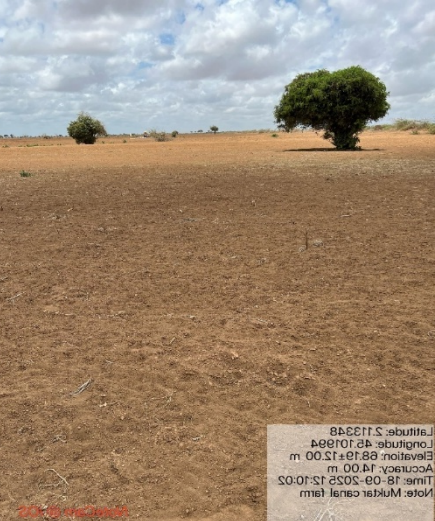
4+000	Farmland	The original command area of the Mukhtar Canal currently receives no water due to the canal's deteriorated condition.

<p data-bbox="646 743 899 772">Figure 4-1 command area</p>	2.139592, 45.08757	It is recommended to rehabilitate the Mukhtar Canal through desilting, reshaping, and lining to restore water flow and improve irrigation efficiency. Installing proper intake and control structures will ensure reliable water distribution, while community-based maintenance can sustain long-term functionality.
-------	----------	---	---	-----------------------	---
